Fachhochschule Hannover
Fakultät II Abt. Maschinenbau

Bachelor- Arbeit

**General description of Marine elevator
installation process, with focus in
improving door installation method**

Hannover, 19 Juni 2009

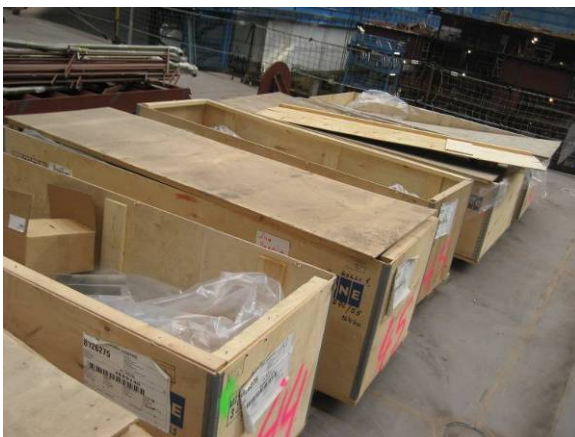
Figure 10. Electrification cable box storage on top of block

First issue regards the delivery schedule of parts, a good example are electrification cables. They are always delivered among the first components, but since they are among the last to be installed, it creates a storage problem at the site. Since storage area at the yard is limited, the cable crates are commonly stored on top of blocks as seen in figure 10, or even worse, on the top deck of the ship. This on the other hand creates friction with the shipyard. It also creates extra work to move the crates around every other day, since they are in someone's way.

For marine installations a temporary electrification solution has been created. This makes it possible to use the elevator during installation phase without any additional electrical material. Therefore the electrical equipment is not needed before the final stages of the installation. This solution includes temporary traveling cable and main switch. The temporary electrification procedure is described in general installation instruction (see appendix 1).

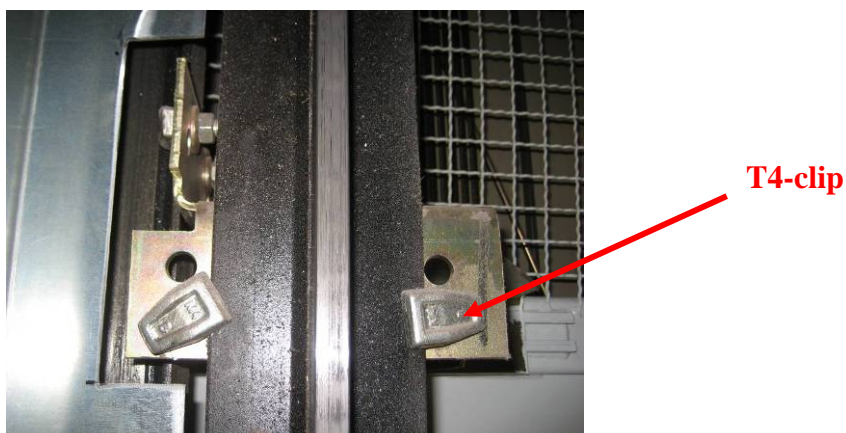
Figure 12. Example of fixing problem with guide rail.

The main problem with guide rail brackets is that the standard M4 T-clip, which is used to fix the guide rail to the bracket, can turn by itself as can be seen in figure 12. This is a serious issue, since if the clips turn during use of elevator, the guide rail gets loose from the bracket fixing. This causes the elevator to run roughly. As a possible solution the M4 T-clip was replaced with a bigger M5 T-clip to prevent the issue with turning. This worked as the bigger head of the M5 was a better fit to the guide profile.

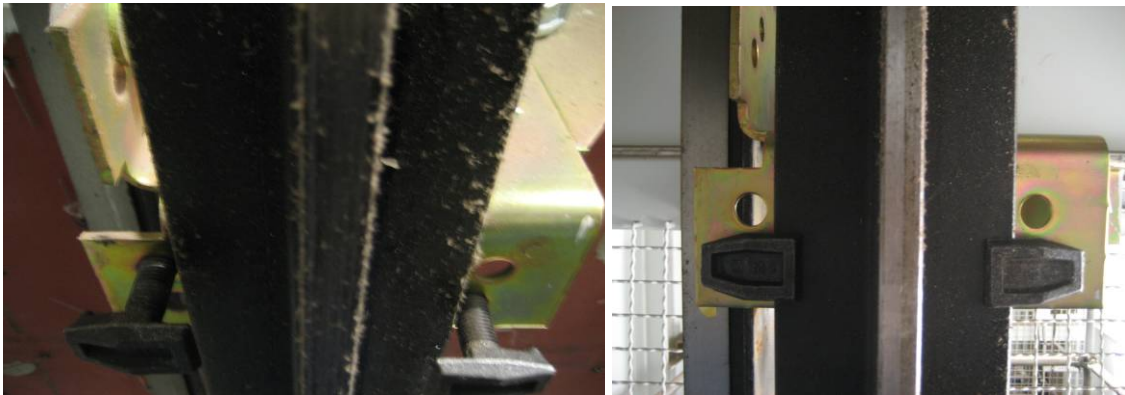
Figure 13. Guide rail bracket T-clips before and after the drilling.

This change caused however another problem. Since the M5 T-clip is bigger it doesn't fit into the brackets holes. The drawing 805043 of the bracket shows the hole diameter for cabin guide rail as 18mm. This is clearly too tight. A test was carried out where the holes were drilled with M20 bore. This test resulted in perfect fit for the M5 T-clips and also proofed that the M5 T-clip functions better by not allowing the clip to turn by itself. Pictures taken before and after the test can be seen in figure 13.

The result of this test requires the drawing to be changed accordingly. The hole dimension has to be changed to 20mm. The changed drawing 805043-p1 can be found in the appendix 5.

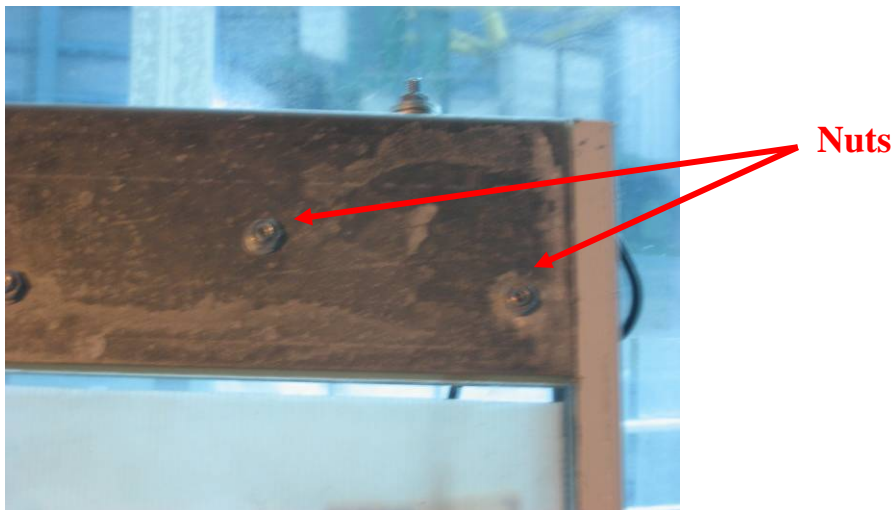
Figure 14. Nuts located at the cabin side of the cabin door.

Since the Panorama cabin doors are not installed at the factory, because of risk of damages during transportation, they have to be installed locally at the site. First issue with the installation is that the nuts holding the glass panel at place (figure 14), are located at the cabin side.

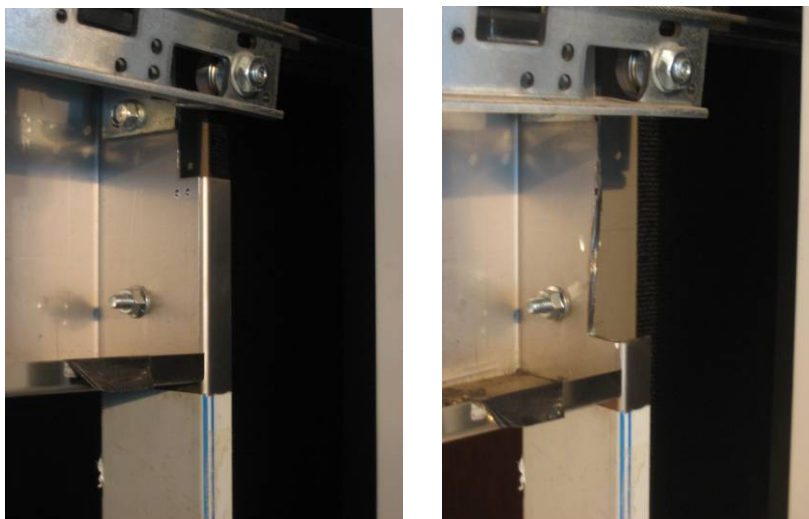
Figure 15. Cabin door frame before and after cutting.

This creates a problem with the door frame since the nuts prevent the door from opening and closing properly, by hitting to the cabin door frame. Therefore the fitter has to cut a hole to the frame in order to make the door work. This procedure can be seen in figure 15.

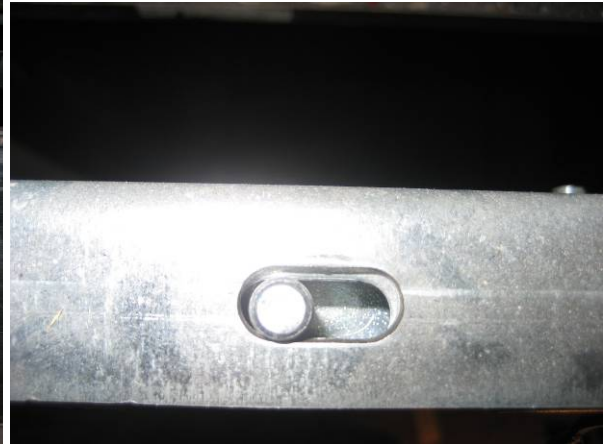
Figure 17. Poor hole alignment.

There is however an issue with the quality of the parts. Usually the peaces don't match, resulting in difficulties during installation. An example, where the holes of the two components are not correctly aligned, can be seen in figure 17. The height of the door panels can also vary. This causes problems when the door is fitted between the sill and railing. If this happens the railing height has to be adjusted before the door fits.

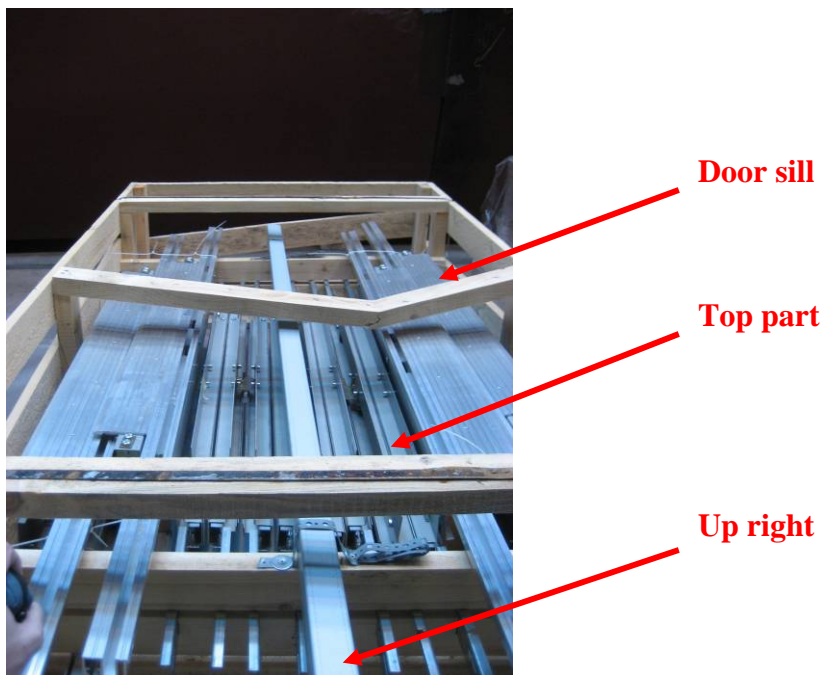
Figure 21. Door frame parts delivery crate.

The parts for landing door assembly are delivered in disorganized way. Now it is done so, that door sills, up rights and top parts are all in the same crate, as can be seen in figure 21. This means that before door frame installation can begin the parts have to be sorted, since only the door sills are needed at the first stage, up rights at the second and so on. It adds time to the door installation preparation phase (chart 2). This could be done much easier and therefore save time. /13/

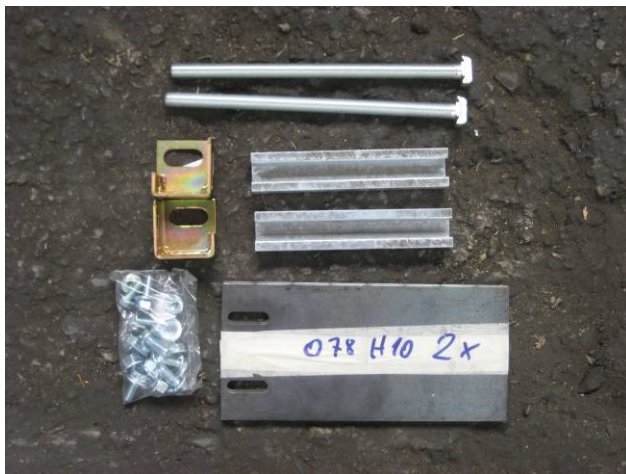
Figure 22. Useless fixing material for landing door railing.

Since the locally developed fast fixing method differs from the one in the installation instruction for marine AMD-door, a lot of unneeded material is delivered to site. For example the crate containing fixing material for landing doors, contains 24 different items. From these items only 8 are used. All the other parts were thrown away. Examples of material thrown away can be seen in figures 22&23. This must incur unnecessary expenses for the company, since it happens with every elevator. Among the parts thrown away are the nut and washer packages for upper fixings. This result in double loss since they are all packed into plastic, therefore also the value of the work put into packing these items is lost./6;13/

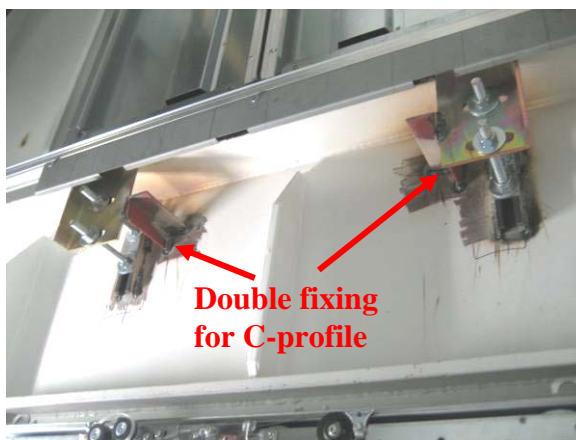
Figure 24. Door sill C-profile fixing.

The current installation manual (AM-03.12.042-MAR) instructs to fix the AMD doors railing and door sill with bolt fixings to a C-profile. In reality only the door sill is fixed this way as seen in figure 24. The frame top part is only fixed at the sides, using side supports which are welded directly onto the trunk wall, fixing extensions are not used, as seen in figure 24. In addition the railing is welded to the trunk wall with flat irons, not with the original fixing plate (also in figure 25).

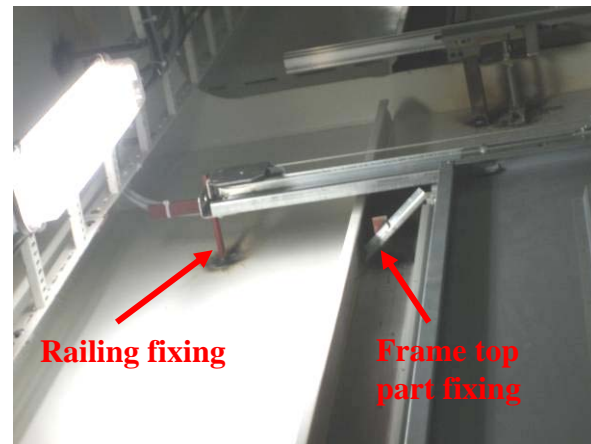
Figure 25. Top part and railing fixing.

These alterations mean that a lot of unneeded fixing material is delivered for each door, the material is introduced in chapter 7.1. This fixing method has been in use for past 7 years without complaints, so the systems functionality can be seen as proved. The original system would require even more welding work done for all fixings. This old method was also much slower to install because of too many different fixing types (brackets and plates). The main issue with the used fixing method however is that, with so much welding (even now) done onto the trunk wall after the shipyard has painted the trunk, both from the inside and outside, the painting has to be done for the second time. The welding marks, shown in figures 24 and 25, have burnt the paint surface from both sides of the trunk. This creates huge amounts of extra work and cost for the yard, or for KONE depending on contract.

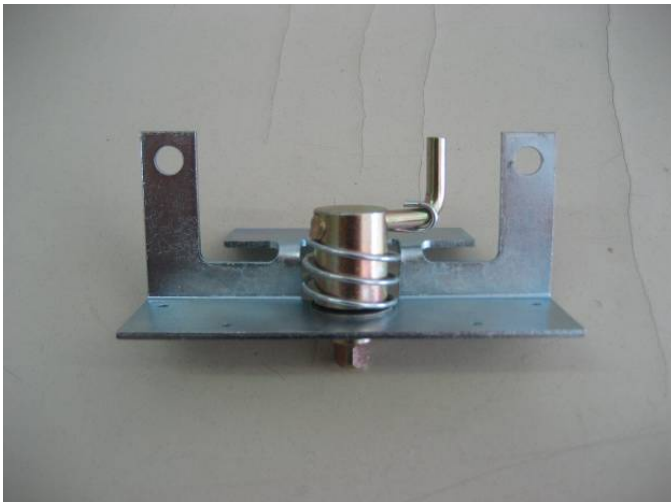
Figure 29. Falsely installed return spring.

A problem occurs constantly with the top part. The door emergency opening device mechanism doesn’t work. The problem is caused by one of two possibilities. The first is that the return spring of the lock is completely missing, second alternative is that it is installed the wrong way, this case is shown in figure 29. This is easy to spot since the ‘handle’ points in the wrong direction.

In the drawing for the emergency door opening device, drawing number 731435G02, the spring position is displayed falsely. This could be the ground reason for the spring being installed the wrong way. It doesn't however explain the cases where the spring is completely missing.

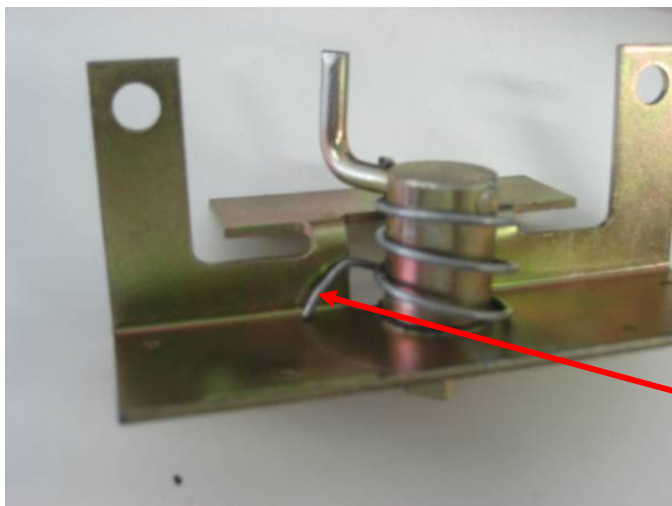
Figure 30. Correctly installed return spring.

**Spring fastened
the right way
functions as a
return spring**

A temporary solution for correctly fastened return spring can be seen in figure 30. As can be seen, to achieve functionality the spring has to be fastened so that it actually returns the lever, instead of just spinning around. This is the case if the spring is left in the condition as it is delivered.

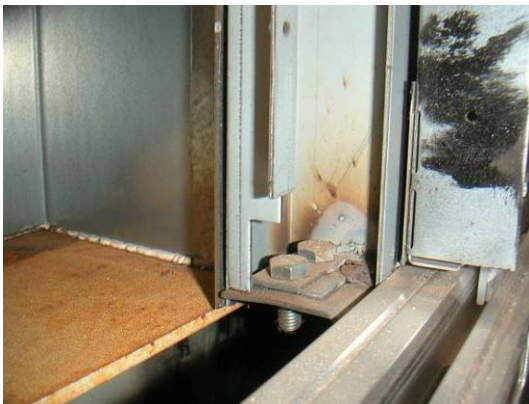
Figure 31. Example of a welded frame up right fixing.

The landing door frames up rights are a good example of the material problems. In this project (NB676) the measured material thickness of the up rights has varied from 1,8mm to 2mm. The drawing for this part specifies the thickness as 2mm. This creates a problem with stability, since even the 2mm thick up rights are a bit unstable. The stability problem has been also noted at the STX shipyard in Turku. /11/

The material thickness of the up right has been reduced twice, according to drawing alteration history (drawing 731007). This has probably been done to save in material costs, but it is not the best alternative for part used in marine environment. The edges of the up right are nowadays also a cause of concern. Since these edges are not rounded after bending process, it is a serious working safety issue. Usually if the frames are handled without gloves there is a high risk of deep cuts and scrapes. Sometimes the weakness of the material causes a problem with the screw fixings of up right and top part or door sill. The screws don't bite to the material and can not therefore hold the assembly together. If the screws won't hold the assembly in place a welding joint has to be added as seen in figure 31. This is off course extra work and it shouldn't be necessary if the parts are produced with the correct quality./16/

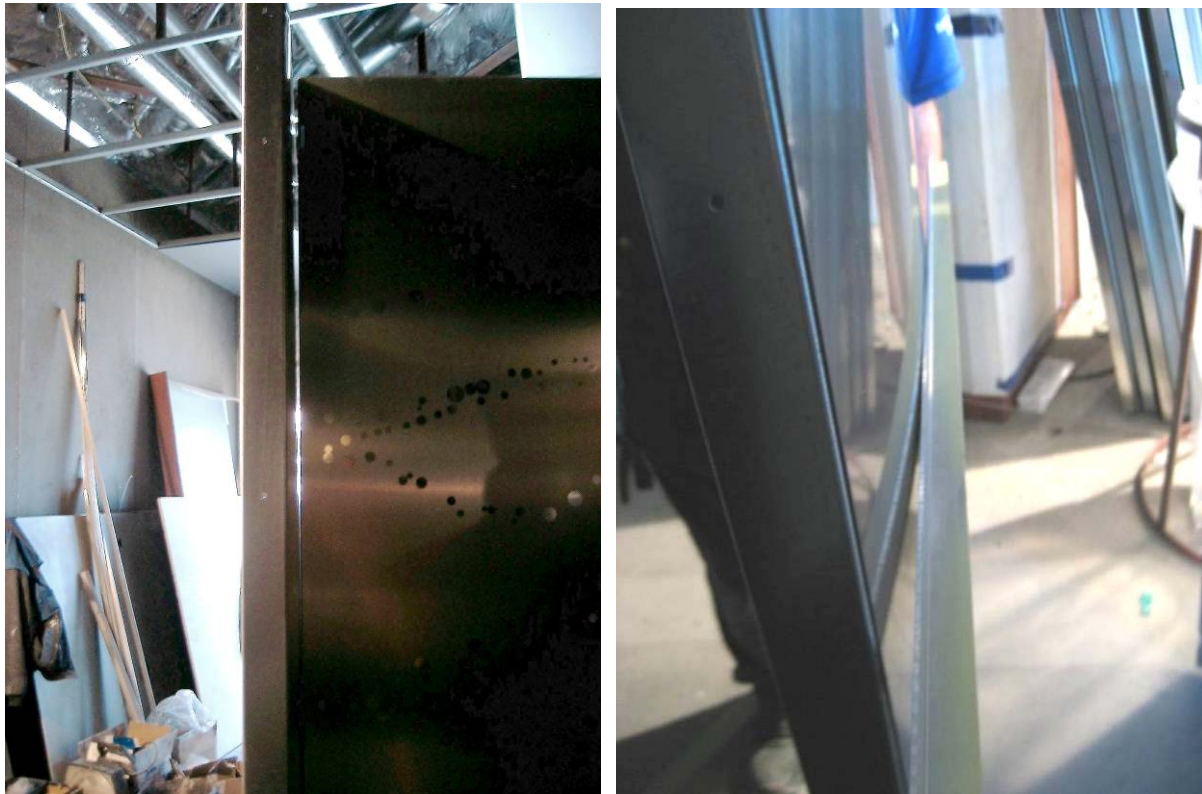
Figure 32. Bent decorative door panels.

The landing door panels are also a notable problem, especially the decorative door panels. At latest new buildings e.g in Solstice (project NB675) the quality of delivered panels has been a problem. An example can be seen in figure 32 from NB676, where the panels are bent both vertically and horizontally. This kind of doors can not be used, since it will not open properly.

The reason for problems with bent landing door panels has been found and the quality control department in Usti is working to solve the issue. Samples of landing doors with broken spot welding were sent to Usti. According to investigations the tip of the welding electrode was too worn out. A procedure has been created to change the welding electrode regularly to avoid similar problems in future. The results of these actions have to be controlled from the next shipment of landing doors. Increased quality control will be performed for the next shipments from Usti by inspecting the landing door panels and the fabrication principles at the factory, before they are sent to the site. If these meet the quality requirements the deliveries can proceed./16;18/

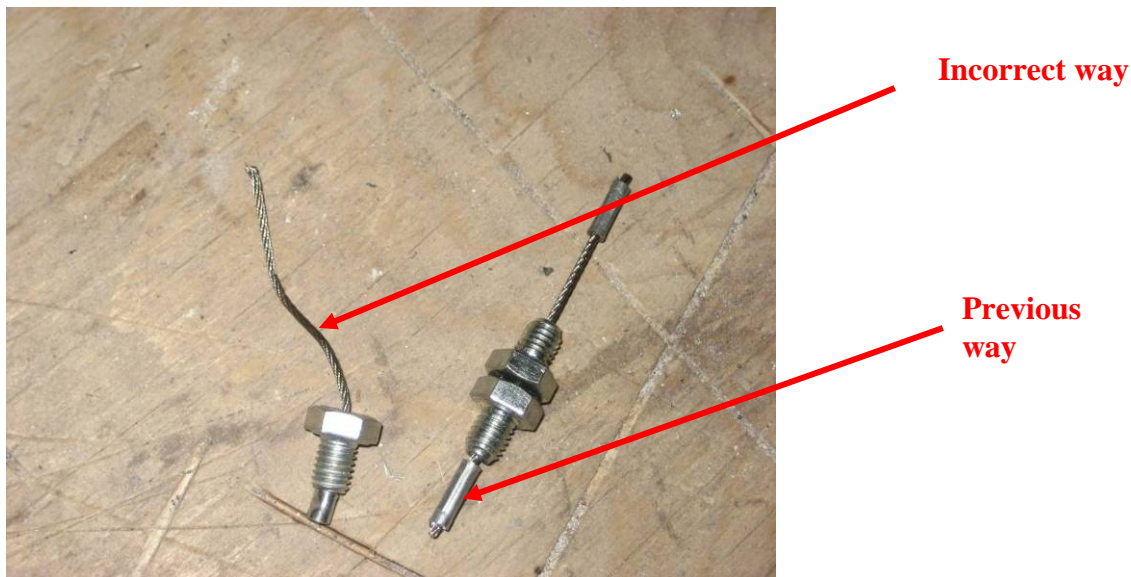
Figure 33. Landing door panel counterweight wires.

The problem lies with the clamping of the wire. From figure 32 can be seen the old way of clamping the wire and the present way, which has resulted in broken connection. As can be seen from figure 33, in the broken assembly the clamp at the end of the rope is very short and the compression mark is too shallow. These issues create a problem where the weight can drop into the bottom of the counterweight shaft or in the worst case with A-60 doors to the bottom of the elevator shaft. For information about door counterweight shaft locations and function refer to appendix 1.

The poor quality of the wire and the wire connection of the door counterweight are a serious problem considering door use. If the wire counterweight assembly breaks during use the door will not close properly in rough weather conditions, resulting in disturbance announcement. This is also a safety issue, if the landing doors remain open after manually opened, someone can fall down the shaft. Fixing these problems at site costs again precious time and resources.
